TECHNICAL REPORT HL-89-19

MODEL STUDY OF PRADO FLOOD-CONTROL DAM

Hydraulic Model Investigator

September 1989

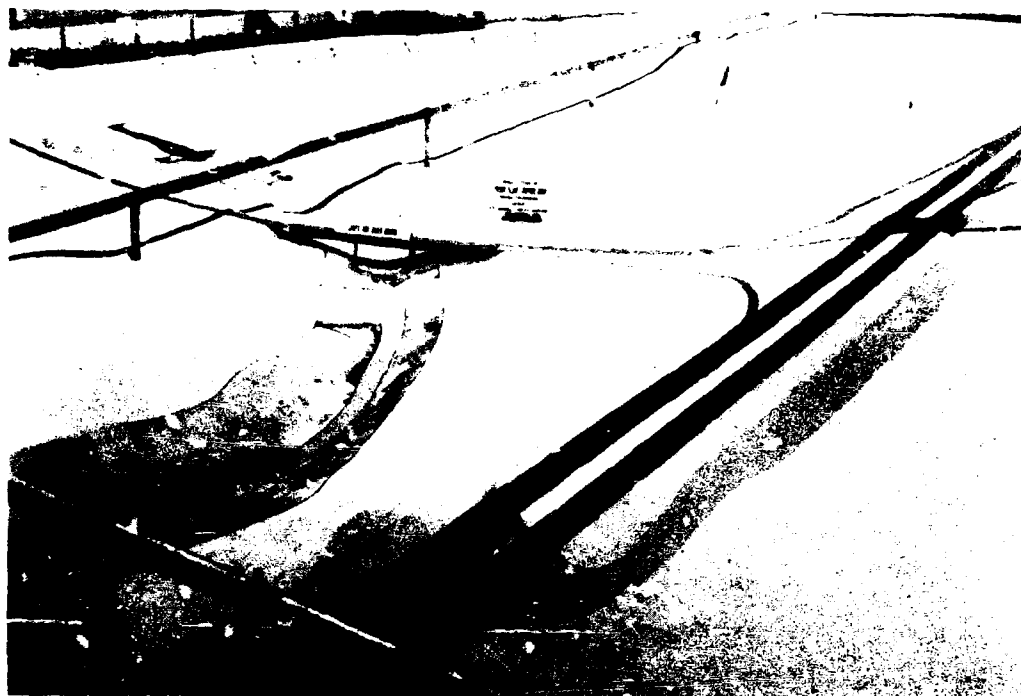
a. Looking upstream

b. Looking downstream

Figure 2. General view of 1:80-scale model

7. The 1:80-scale model (Figure 2, Plate 2) reproduced approximately 1,500 ft of approach channel to the spillway, the spillway (Photo 1) and dam, the outlet works stilling basin and intake tower (Photo 2), and approximately 3,400 ft of exit channel. The spillway was constructed of sheet metal, and the intake tower and outlet works stilling basin were constructed of transparent plastic. The approach and exit channels and dam were molded in sand and cement mortar to sheet metal templates.
